Safety of Busses and Coaches: Current Situation and Priorities for Future Researches

Dominique Cesari

French National Institute for Transport and Safety Research, Lyon, France/ Hunan University, China

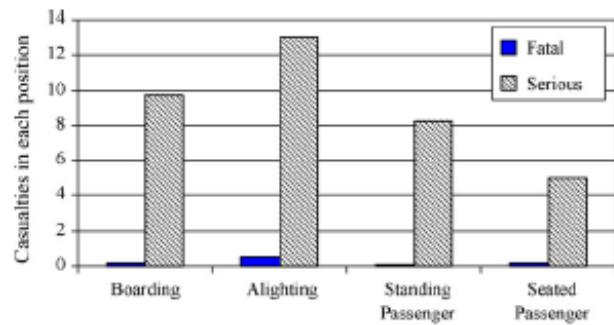
Figure 3. Situations producing severe and fatal injuries to bus and coach occupants

The most frequent situations in which a bus or coach occupant sustains injuries are when he leaves the vehicle, followed by boarding; inside the vehicle more standing occupants than those seated are injured, but seated occupants are more likely to sustain fatal injuries. The latter relates to severe coach accidents in which all occupants are seated.

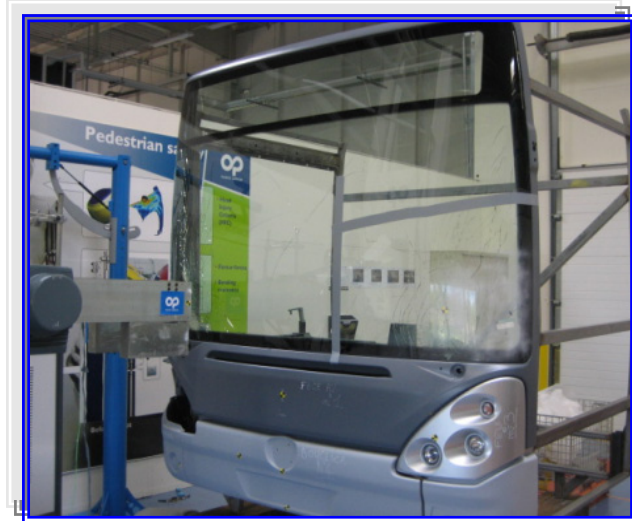
Figure 5. Areas tested for pedestrian protection improvement

This evaluation was completed by dummy tests involving the same components of the bus front face. These tests show the importance of head and leg protection, similar to car impacts, but also the importance of thoracic injuries unlike car impacts.

Leg restraint depends directly from the geometry of the front face, especially too high lower bumper level would allow the pedestrian legs going under the bus corresponding to a high bending moment applied to the legs. In case of child pedestrian, this would produce a kinematic pushing the child forward to the ground, with a high risk of being run over by the bus.

The most relevant project, called Prudent VI (5), investigates the possibility to design a bus front face less aggressive to pedestrian. The project first evaluated the stiffness of different areas of the front face in pedestrian impact conditions as indicated on figure 5.

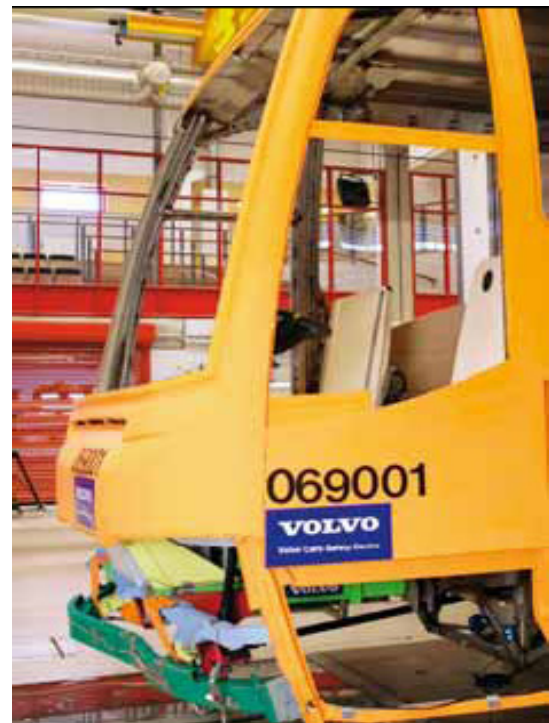
Figure 6. Front underrun protection for bus

Several projects looked at compatibility between bus and car in frontal collision, and as for trucks it is proposed to fit the lower of the front face with an energy absorbing front underrun protection (EAFUP), as shown on figure 6.

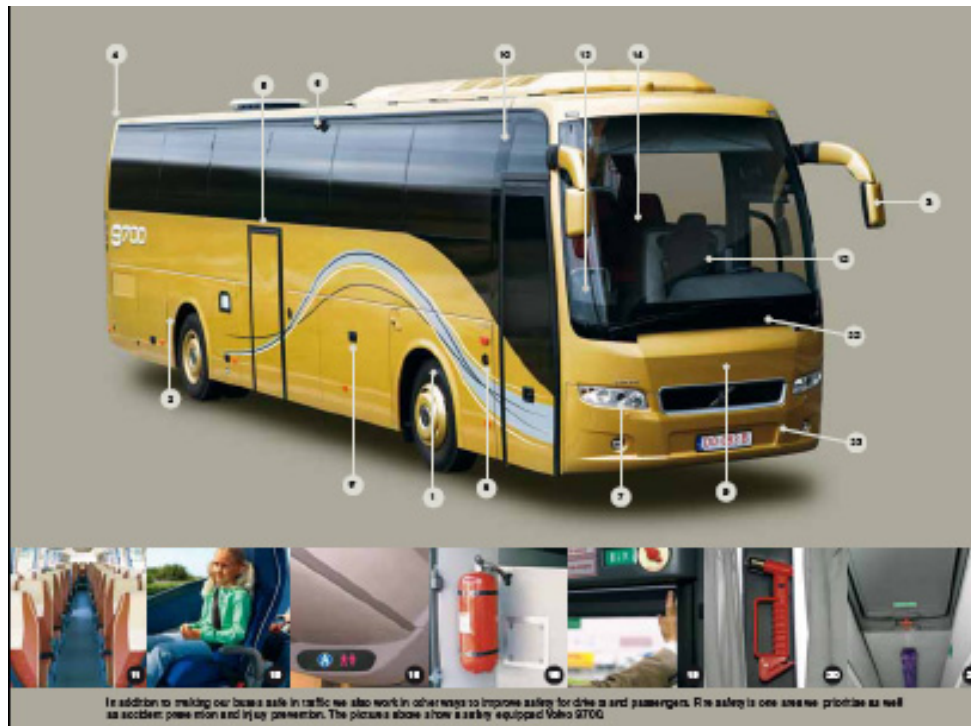
Figure 7. Technologies aimed at improving coach safety (1 Electronic Disc brake & ESP, 3 + 4 «All around» rear view, 19 + 21 Emergency exits, 12 to 16 Restrain systems, 23 Front underrun, 10 Rollover protection, 6 + 7 Improved lighting, 11 + 22 Interior protection, 18 to 21 Passenger evacuation)
