Impact Experimental Investigation of PVB Laminated Glass Based on High-Speed Photography: An Initial Attempt

Abstract: In this paper, a high-speed photography method combined with drop-weight test is used to study the dynamic cracking behavior of PVB (polyvinyl butyral) laminated glass subject to low-speed impact. Crack patterns, paths and velocities, derived from a series of dynamic photos, are thoroughly analyzed to explore the characteristics cracking propagation. In addition, given the different the experimental conditions, i.e. different crack velocities, cracking speed (including maximum speed and speed-time history curve) are examined and compared.

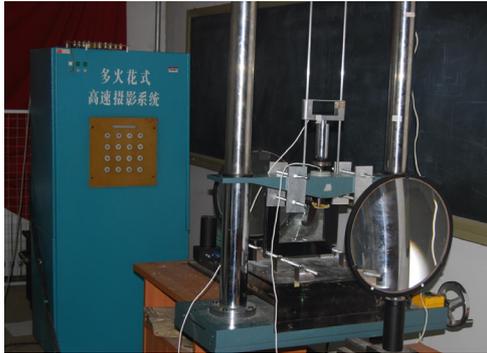
Figure 1. High-speed photography experimental system

The high-speed photography system includes a 4×4 array spark generator, two convex lenses and 4×4 array camera, as shown in Fig.1. The generated sparks are considered as point light sources, the interval between which can be set from 1μs to 9999μs. Two lenses including the objective one and the eyepiece one, with 1550mm focal length and 400mm diameter, provide the paralleling lights which transmit through the specimen and ensure clear photos capture. The impact load is applied at the centre

point of the specimen by an impactor which is struck by a drop weight with initial height $h=1000\text{mm}$. Synchronization of impact loading and the high speed camera is realized by a contact circuit. It will be connected when the falling weight contacts the top surface of the impact convertor, triggering with set-in-advance intervals, which is $10\mu\text{s}$ in this experiment.

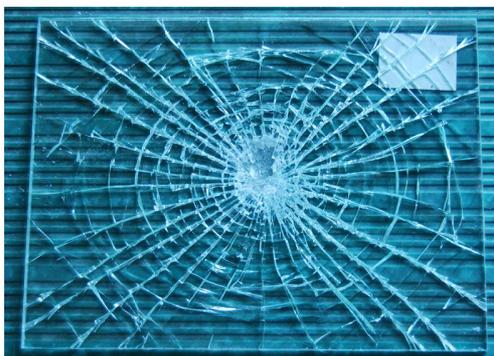
Figure 2. Specimen after impact

Fig.2 shows the specimen after impact. Fig.3 (a)-(i) demonstrates a series of high-speed photographs of dynamic fracture of PVB laminated glass specimen. Two kinds of cracks including radial cracks and circumferential cracks can be observed from both the photos and the specimen. The circumferential cracks only appear after $100\mu\text{s}$. This phenomenon strongly supports the result given in Xu ^[1, 10] that the radial crack comes before the circumferential one. The crack tip positions at each time point derived from these photos will be used to obtain further fracture parameters such as crack length and speed.

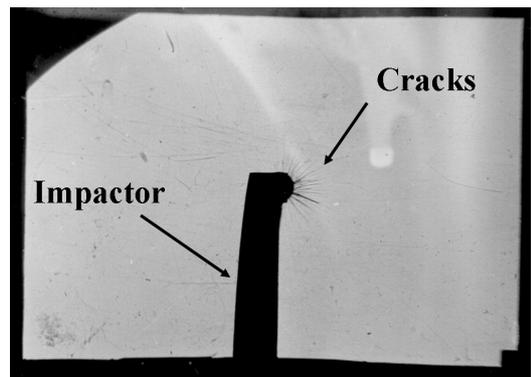
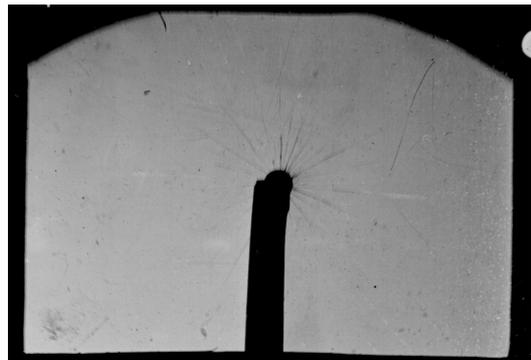
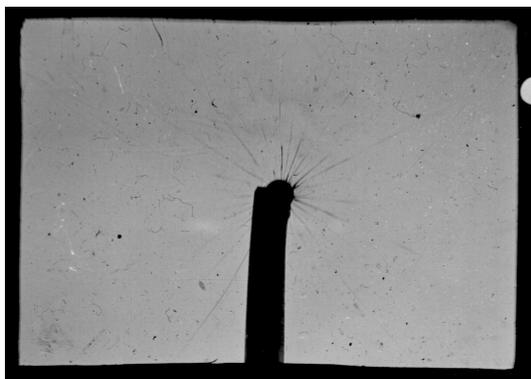
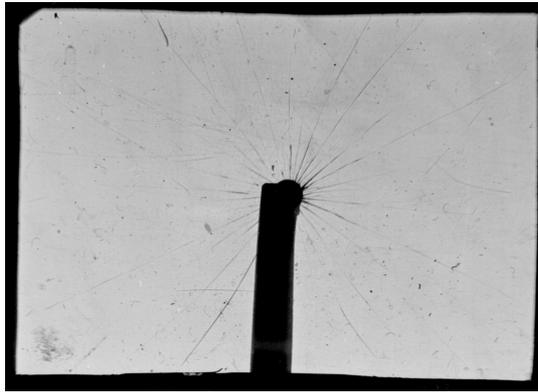
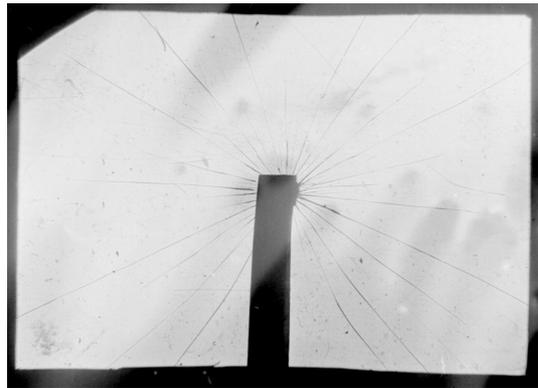
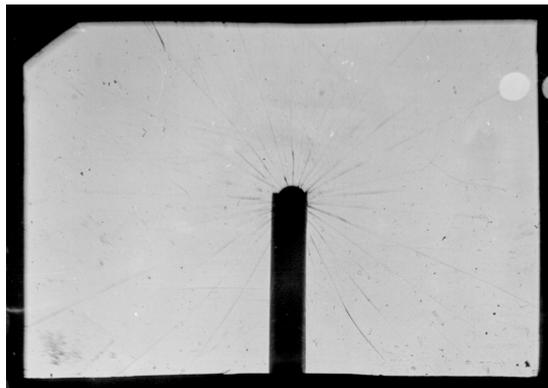
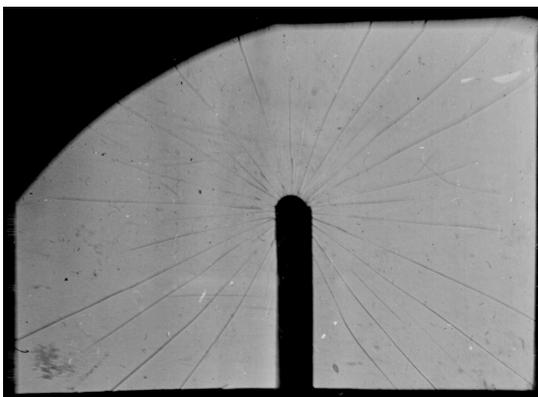
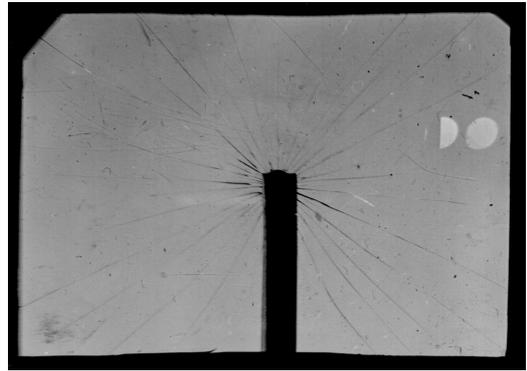
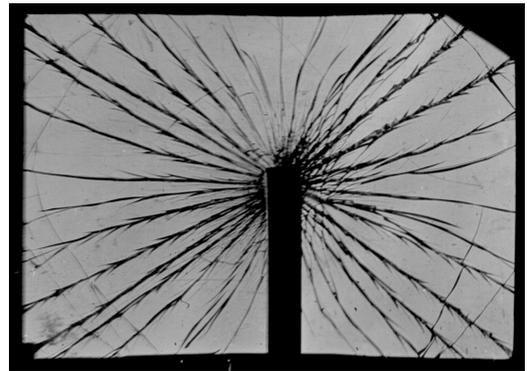
(a) $t=10\mu\text{s}$

(b) $t=20\mu\text{s}$

(c) $t=40\mu\text{s}$

(d) $t=60\mu\text{s}$

(e) $t=70\mu\text{s}$

(f) $t=80\mu\text{s}$

(g) $t=90\mu\text{s}$

(h) $t=100\mu\text{s}$

3(i) $t=600\mu\text{s}$

Figure 3. Dynamic cracking evolution under the impact height of 1000mm, impact weight of 2kg

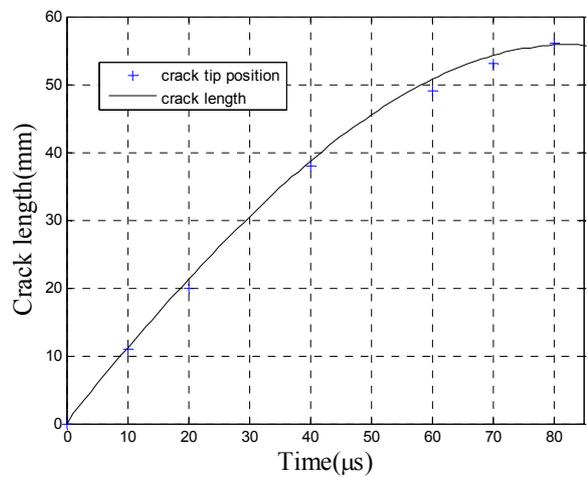
Figure 4. Crack growth history under the drop height of 1000mm

Due to the inevitable internal stochastic flaws inside the glass, the lengths of cracks in each photo are not the same. Therefore, the average lengths of cracks are calculated in order to obtain the crack growth history. Fig.4 shows the crack growth history during $0\mu\text{s}\sim 80\mu\text{s}$ after impact. Solid lines are acquired through optimized fitting procedure.

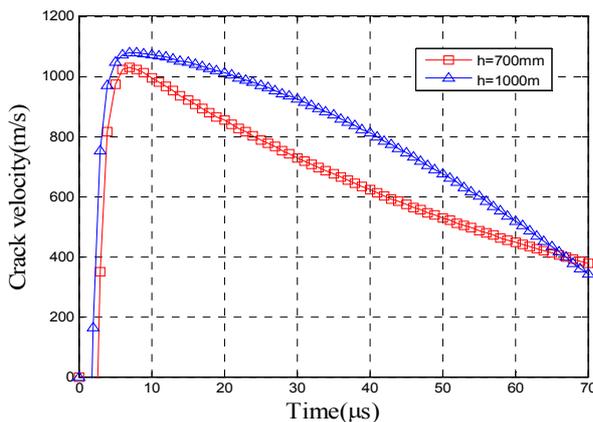
Figure 5. Velocity under different initial heights

Crack velocity history is calculated from crack growth history by numerical derivation, as shown in Fig.5. It is observed that the maximum crack velocity appears at the initiation period (about 2 μ s), which is $v_{\max} \approx 1080\text{m/s}$. Then the propagation speed decreases with the increase of crack length, till the crack reaches the boundary. The average velocity during 10 μ s and 60 μ s is $v_{\text{avg}} \approx 851\text{m/s}$. At the very beginning, the cracking speed soars up to the maximum propagation speed and gradually decreases. Usually, the cracking speed-time curvature will go into the stable cracking speed domain^[11]; however, in our cases the speeds gradually drop to a very low speed rather than stably cracking. That's mainly due to the small size of our experiment specimen and the crack quickly approaches the boundaries.

To investigate the relationship between initial height of drop weight and crack velocity, the same experiment is conducted with initial height $h=700\text{mm}$. The crack velocities under different experimental speeds are compared in Fig.5. The result indicates that with lower initial height, which also means lower impact energy, the crack propagation trend remains the same, but the crack velocity is reduced obviously. The maximum velocity v_{\max} drops 4.5%, from 1080m/s to 1031m/s and the average velocity v_{avg} drops 18.3%, from 851m/s to 695m/s, respectively.
